WALL PAINTINGS AND PLASTERS OF SİDE HARBOUR BATHS: TECHNIQUES, PROBLEMS, AND CONSERVATION METHODOLOGY

Bekir Eskici

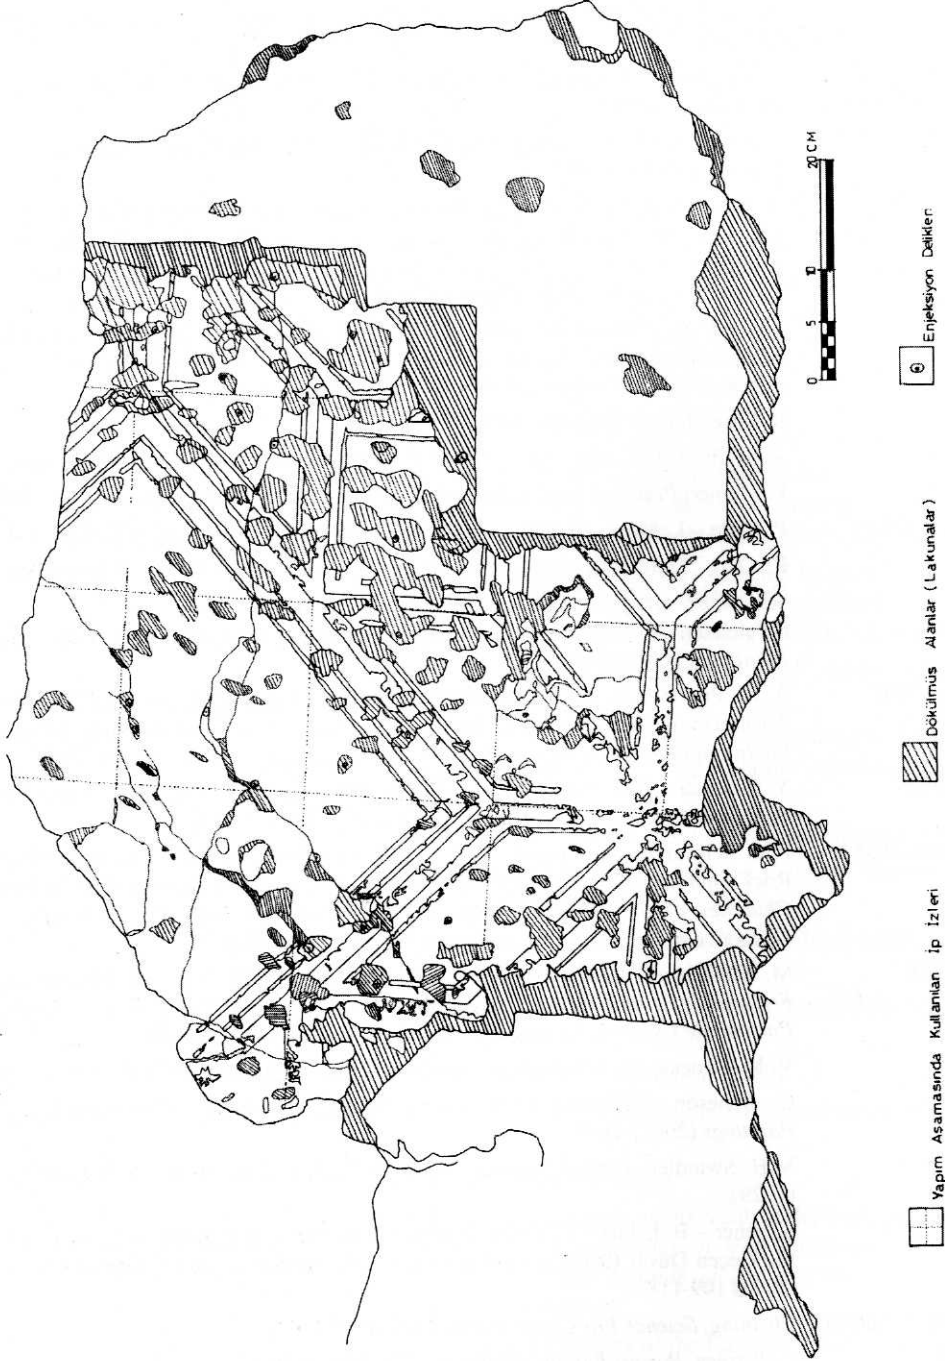
Figure 1

Traces of a rope (or a thread) that reveal information on the application technique were uncovered on the first layer of wall paintings, which have been brought into light through the cleaning process (Fig. 5). From these traces, it is understood that the surface is first divided into equal squares (18x17 cm) with thin bands in vertical and horizontal directions and in this way, the sketch drawing (design) is transferred on the wall without causing an error⁶ (Fig. 1).

- Figure 1** Side Harbour Baths, original wall painting remnant revealed after the conservation.
- Figure 2** Side Harbour Baths, restitution of the original wall painting decoration.

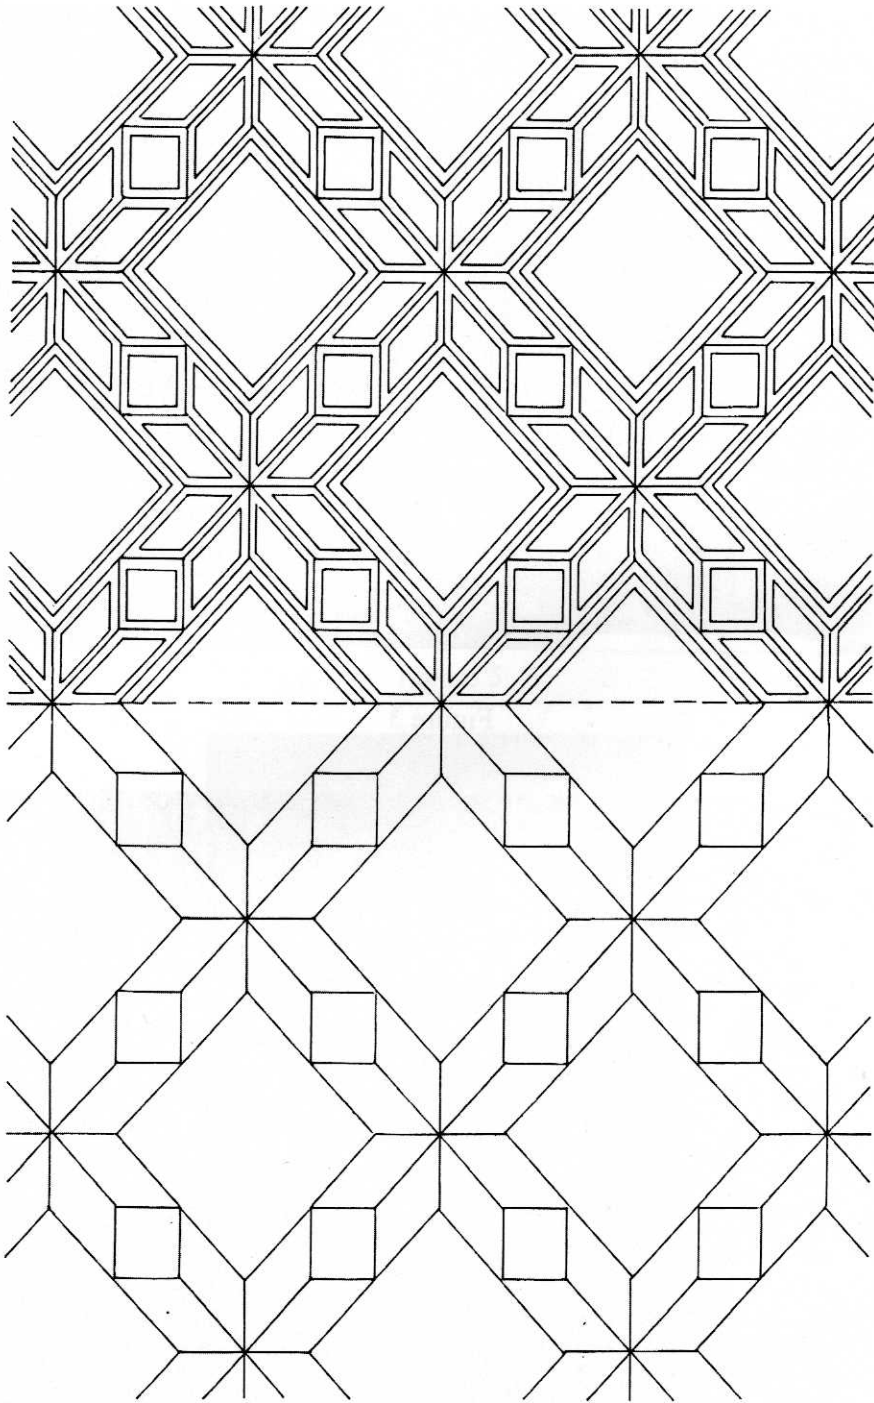
Figure 2

Thus, the remains of painted decoration on the southern wall of the area from the first and from the later periods of the building were revealed (Fig. 12). Unfortunately, only an approximately 1 m² part of this painted decoration has survived (Fig. 1). The first layer of this consists of a geometrical composition²⁰ (Fig. 2). The design is formed

with black and red bands on a light (white) background. The plaster remains of the second layer survived at some spots on very small areas. Contrary to the first layer, remains of the motif which resembles a curved twig and painted on light background with black gives evidence for the presence of a floral decoration.

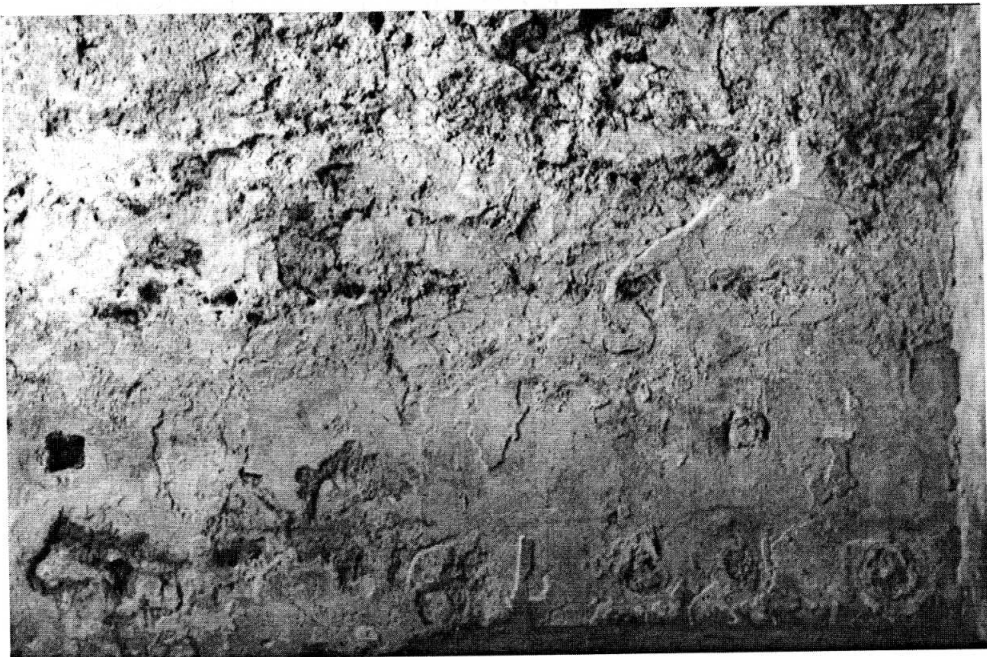
Figure 4

an application of the second painting layer from later periods is visible (Fig. 4). The thickness of mortar varies between 2-5 cm, that of the plaster is 4-6 mm and that of the finishing plaster is 1-2 mm thick according to the evenness of the wall surface⁵. On the plasters, paint remnants in different colours (white, red, black, green) were discovered after the cleaning process.

- Figure 3** Side Harbour Baths, a view from the southern facade.
- Figure 4** Side Harbour Baths, plaster remnant (pre-conservation condition)
- Figure 5** Side Harbour Baths, original wire (thread) traces on the plaster.

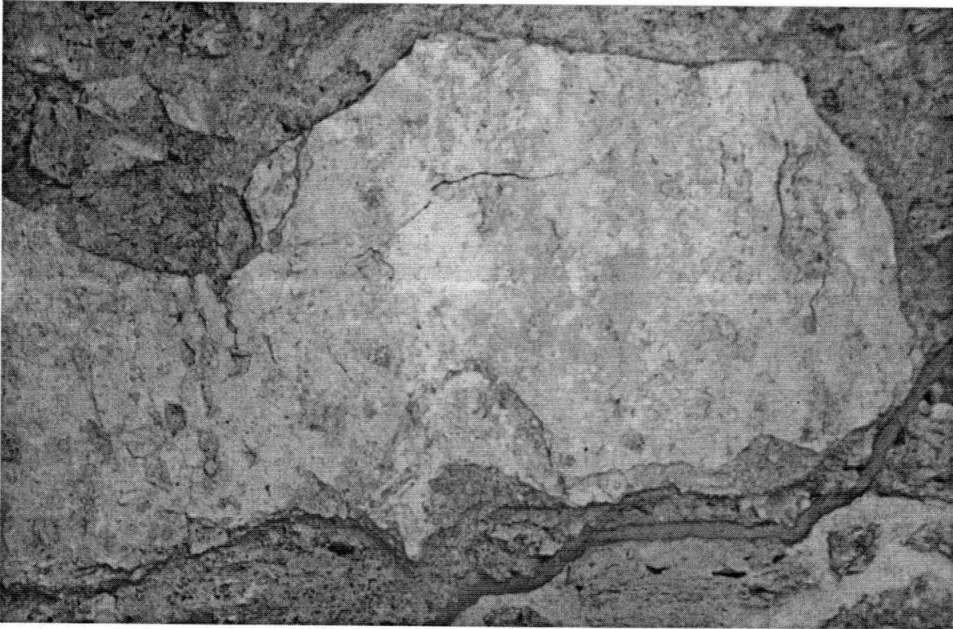
Figure 10

- Figure 9** Side Harbour Baths, consolidation studies with liquid mortar injection.
- Figure 10** Side Harbour Baths, recent time plaster layer covering the original wall painting.

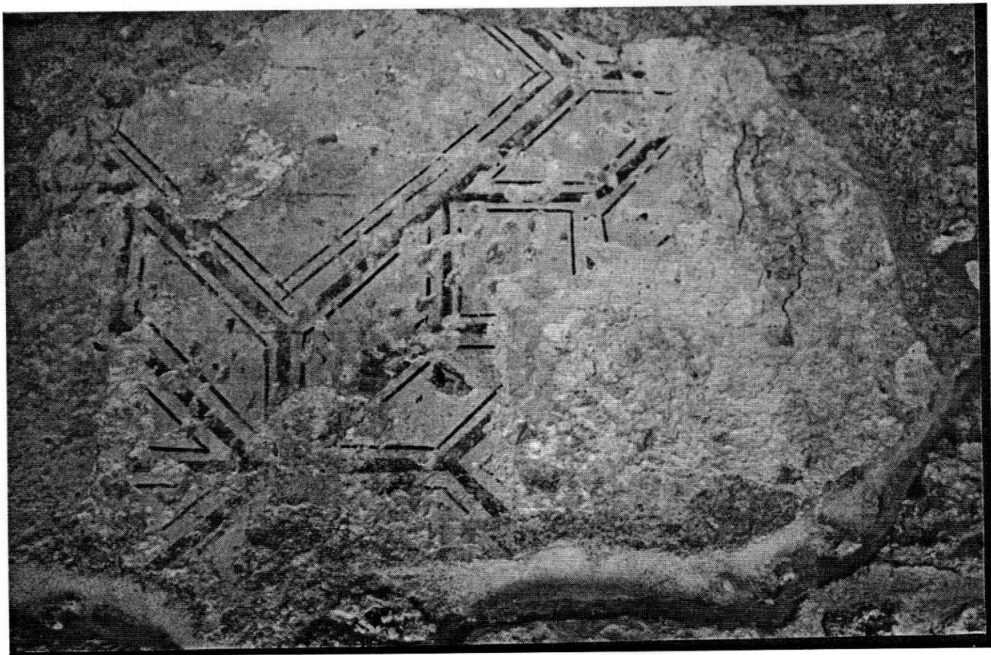
Figure 12

- Figure 11** Side Harbour Baths, removal of the upper recent time plaster layer.
- Figure 12** Side Harbour Baths, original wall painting under the recent time plaster layer.

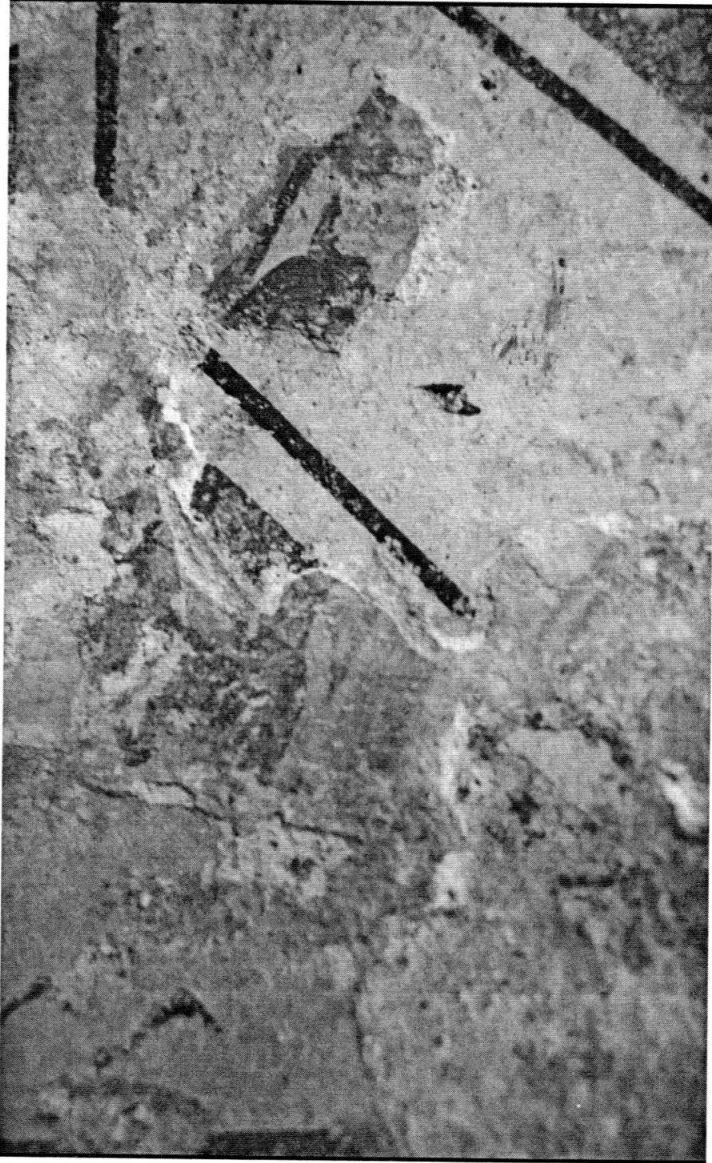
Figure 13

- Figure 13** Side Harbour Baths, remains of the second layer of painted plaster on the original wall painting, detail.
