WALL PAINTINGS AND PLASTERS OF SİDE HARBOUR BATHS: TECHNIQUES, PROBLEMS, AND CONSERVATION METHODOLOGY

Bekir Eskici

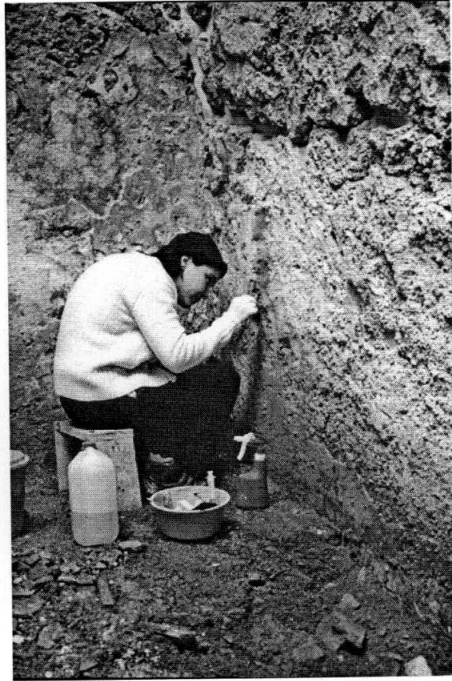
Figure 7

- Figure 6** Side Harbour Baths, cleaning studies with the wrapping method.
- Figure 7** Side Harbour Baths, cleaning and consolidation studies.
- Figure 8** Side Harbour Baths, cleaning and consolidation studies.
